Sample Specification

Type : Ceramic Patch Antenna
 Amotech Part No : A25-4102920-AMT02
 Customer Part No :

SPECIFICATION	PAGE
	A25-4102920-AMT02	2/4

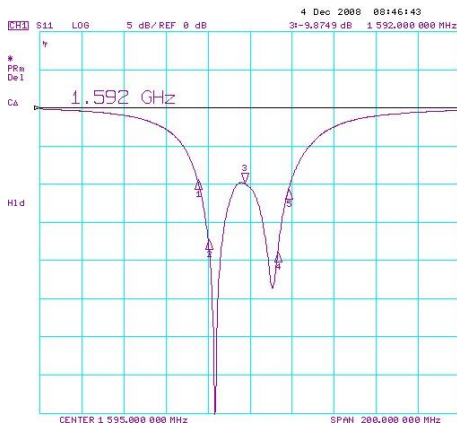
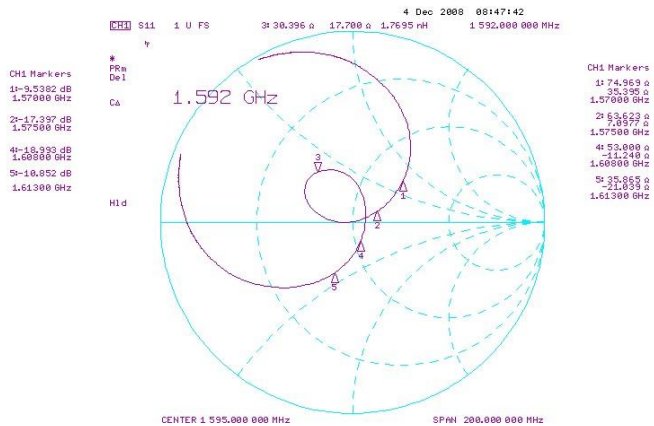
1.2 Typical S11 (Return Loss & Smith chart)

※ Measured on 70x70mm FR4 ground plane (AMOTECH STD jig) with adhesive tape.

- fc is mid point of loop/cusp in smith chart.

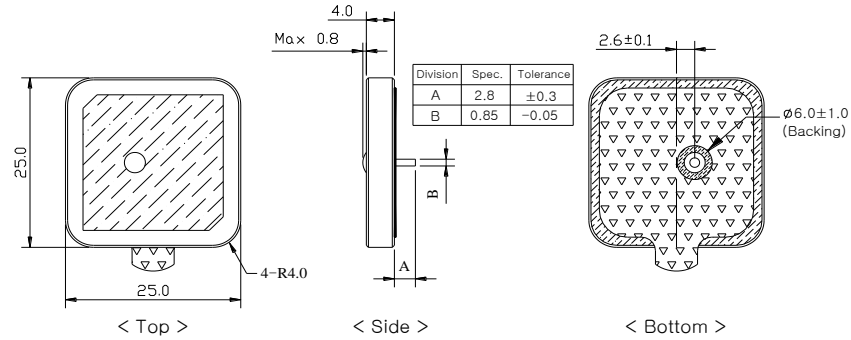
2.1 Dimension

1. Unit : mm
2. X.X : ± 0.3
3. All Around Both Sides Max. 0.3 Chamfer
